DOE/NASA 0017/2  
NASA CR-165197  
DDA EDR 10383

## **CERAMIC APPLICATIONS IN TURBINE ENGINES**

### **Progress Report for 1 January 1980 to 30 June 1980**

Detroit Diesel Allison Division  
General Motors Corporation

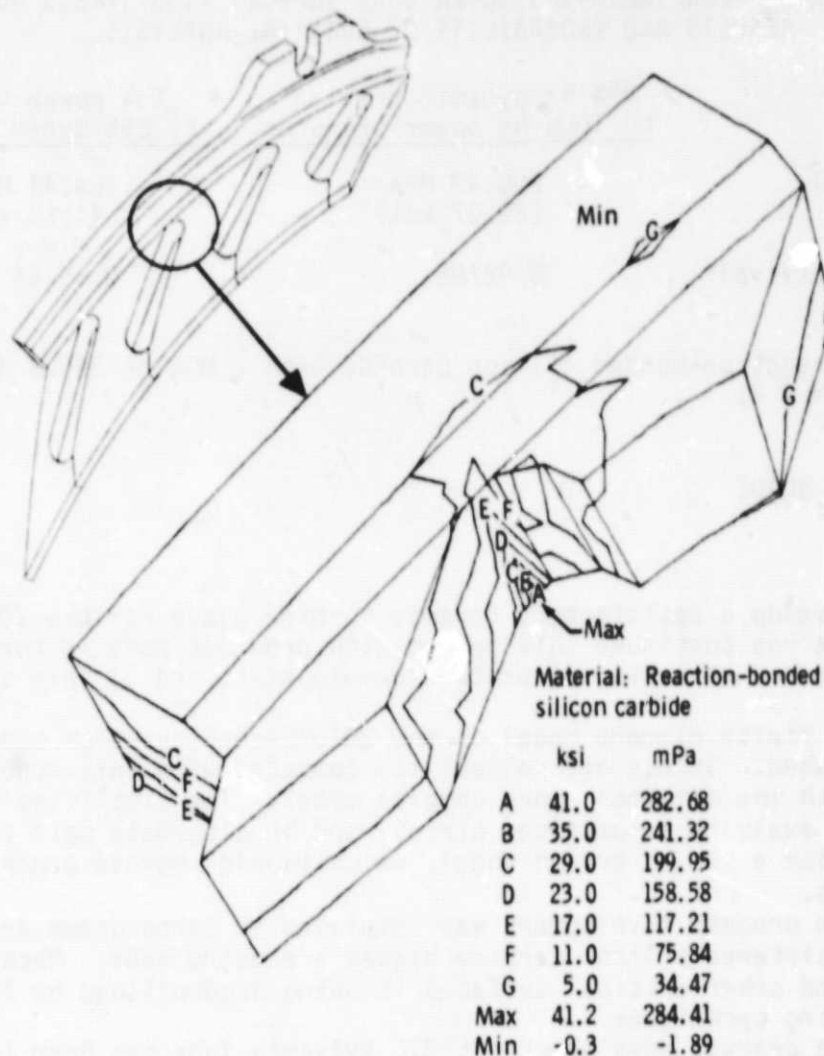
While both of the survival rates are below the production design goal of Table XV, they are still well above the development goal of 0.9. The maximum stresses for both transient cases are located at the back corner of the vane pocket. These stresses occur from a combination of the radial heating and/or cooling of the ring during transients and the stress concentration effect of the vane pocket.

Figure 91. Outer vane support ring maximum principal stress at 24 s into transient thermal cool-down from 85%  $N_G$  power transfer to 85%  $N_G$  dynamic braking.

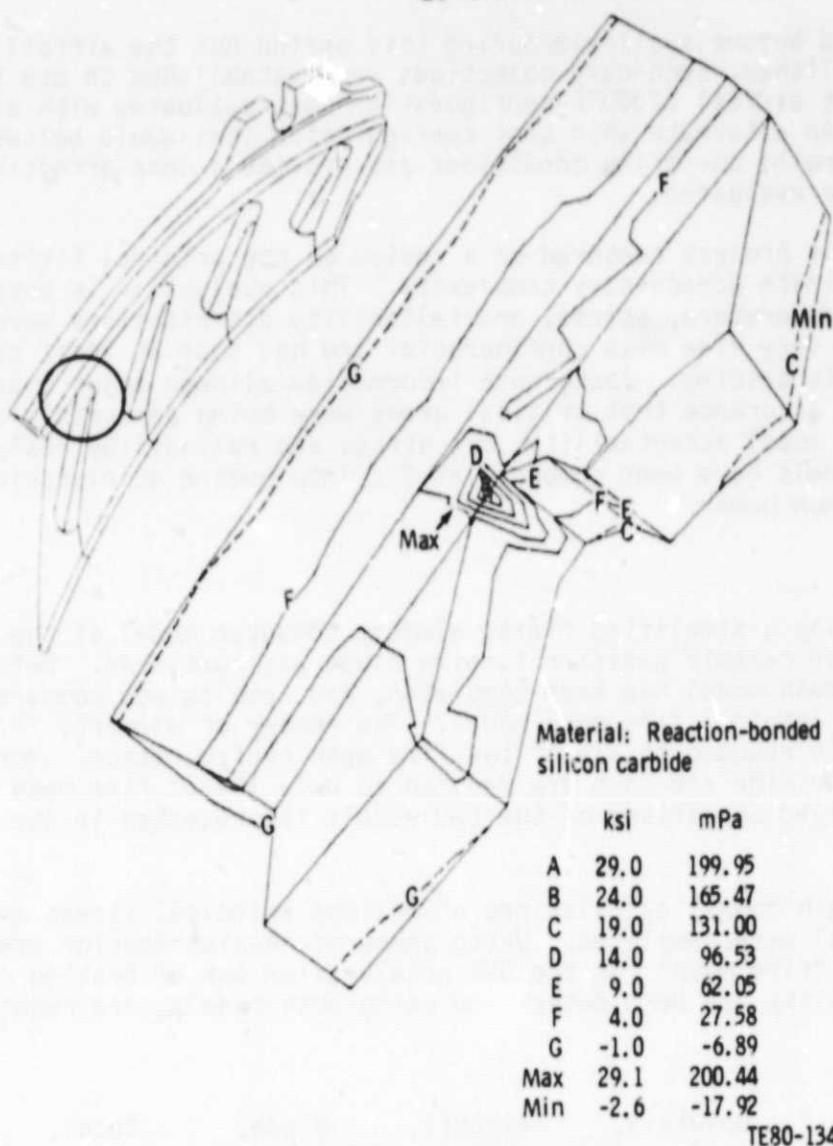
Figure 92. Outer vane support ring maximum principal stress at 14 s into transient thermal heat-up from 85% NG dynamic braking to 100% NG power transfer.

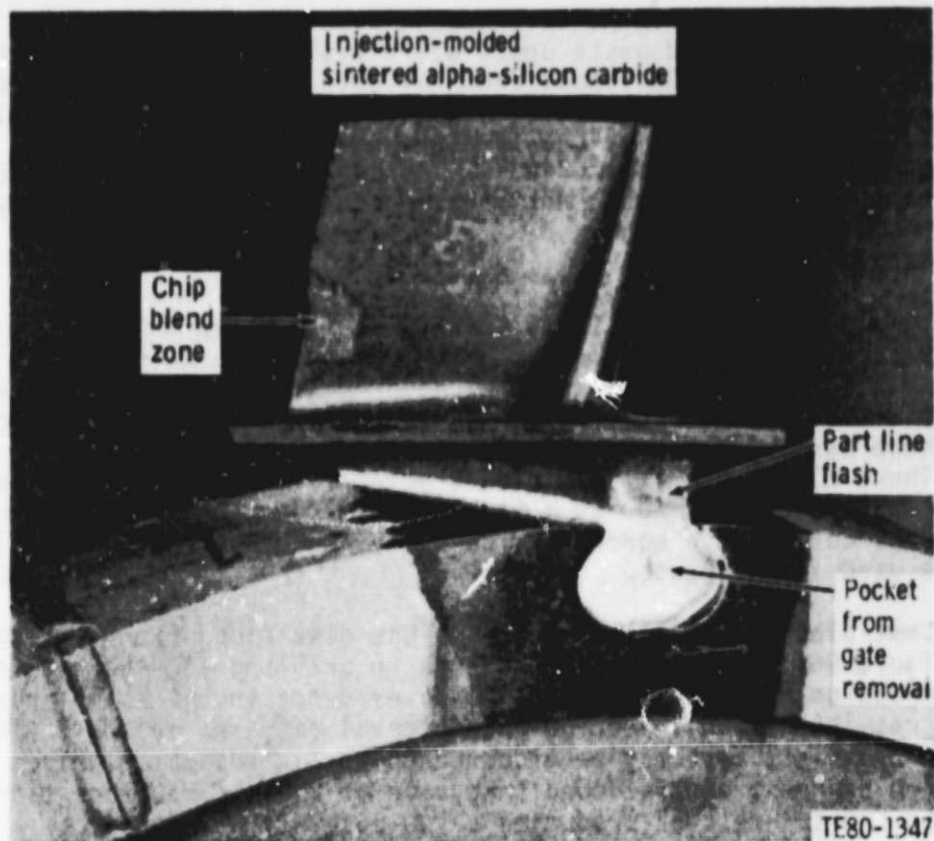
The first test blade (S/N 115) is shown in the disk slot prior to test, as shown in Figure 96. Note hand-blended area in trailing edge to remove a small chip and injection mold die part line flash evidence in the stalk area. A depression resulting from injection gate removal can also be seen. These are considered conditions that may be encountered in the injection-molded blade manufacturing process. It is hoped that some of these conditions can be tolerated in the interest of producing a low-cost reliable product.

Figure 96. Prototype blade ready for spin test.

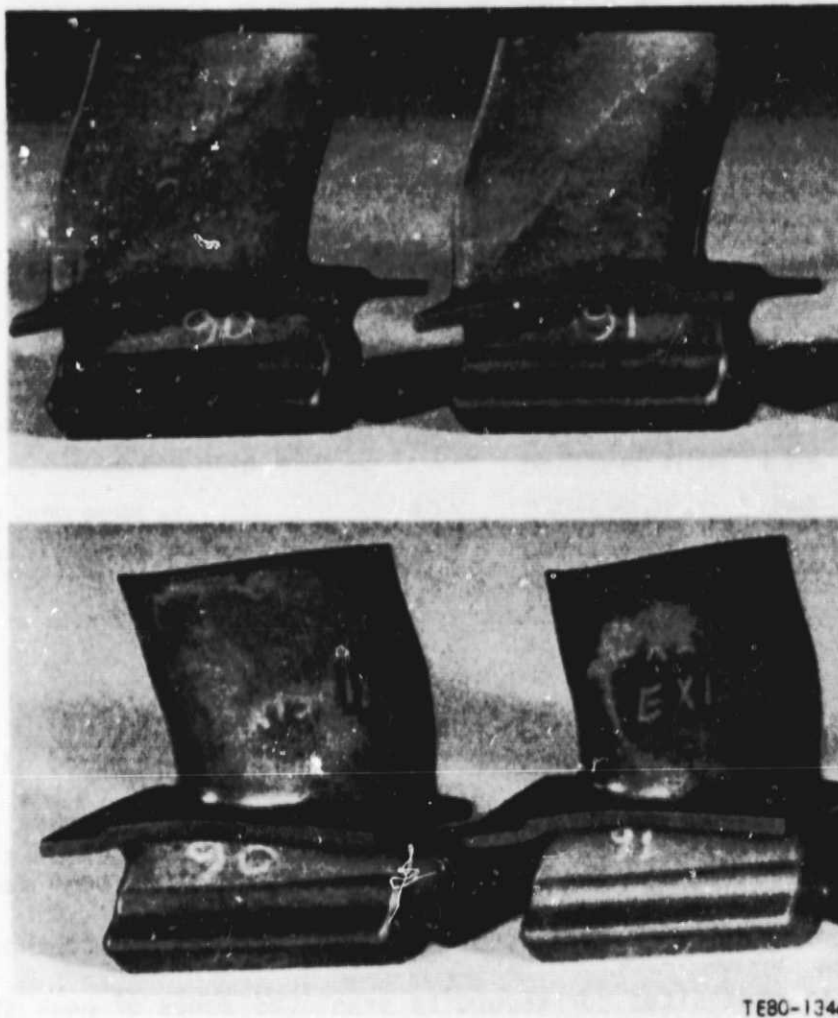
First tests were accomplished on a group of six blades, which had been preoxidized for 24 h at 1250°C (2282°F) in air as indicated desirable from the MOR bar evaluations. Two examples of these blades are shown in Figure 98. Each of the six were run overspeed-to-failure and results are listed in the upper portion of Table XIX. Five were tested at ambient temperature, and one blade (S/N 17) was evaluated at 677°C (1250°F). Failure speeds ranged from 105.7% (of 36,905 rated engine speed) to 127.4% with a mean of 116%. This average is below a predicted failure speed of 131%, which is based on material average strength of 342.7 MPa (49.7 ksi) and a Weibull modulus of 7.9.

The flaws found at fracture origins are similar in size and nature to those flaws that control strength in test bars and are not considered abnormal. The blades did have a glassy coating that may have affected part strength. Investigation revealed that the preoxidation treatment had been accomplished using Al<sub>2</sub>O<sub>3</sub> furnace set plates. It is felt that this produced the thick glassy layers on these six blades. Silicon carbide furnace set plates have been used in heat treatment of all other silicon carbide bars, coupons, or blades.

Figure 98. 2070°F blades prior to spin test--S/N FX24890 and FX24891.

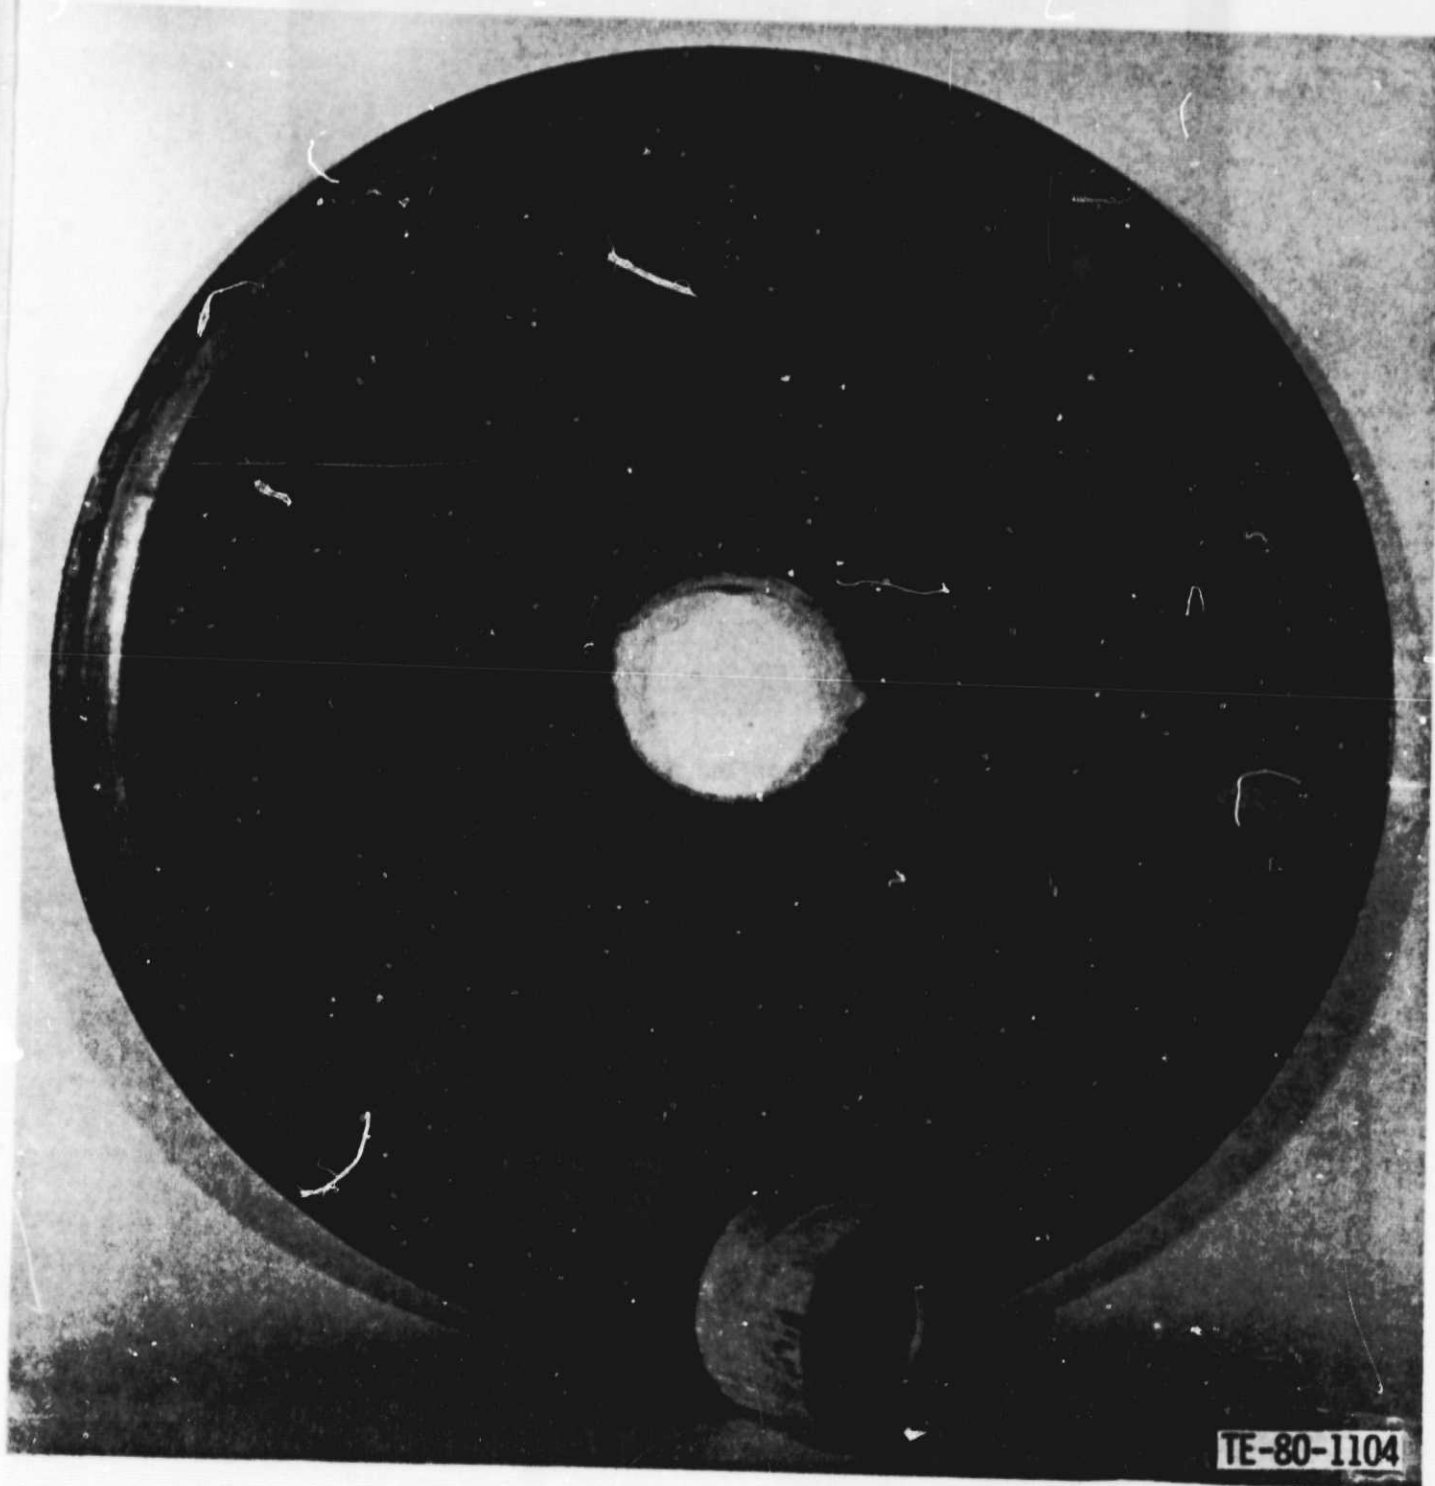
A fourth disk failure occurred out of the 34 disks that have been run in the CATE and transit bus programs. Figures 99 through 101 show the failure. This and the first disk failure were adjacent to the hub, whereas the second and third were at 25- and 28-cm (10- and 11-in.) radii. All four failures were circumferential. Unlike the first three failures, which were short term, this disk failed after 460 h of engine operation. The first and second failures had occurred the first time those disks were exposed to full pressure in the regenerator rig with only 45 min at full pressure. Stress analysis shows that, for the 1900°F-configuration engine, maximum stress at the outside diameter is largely a result of the requirement that the disk rim support full compressor discharge pressure.

Figure 99. Bus ceramic regenerator disk with hub breakout.

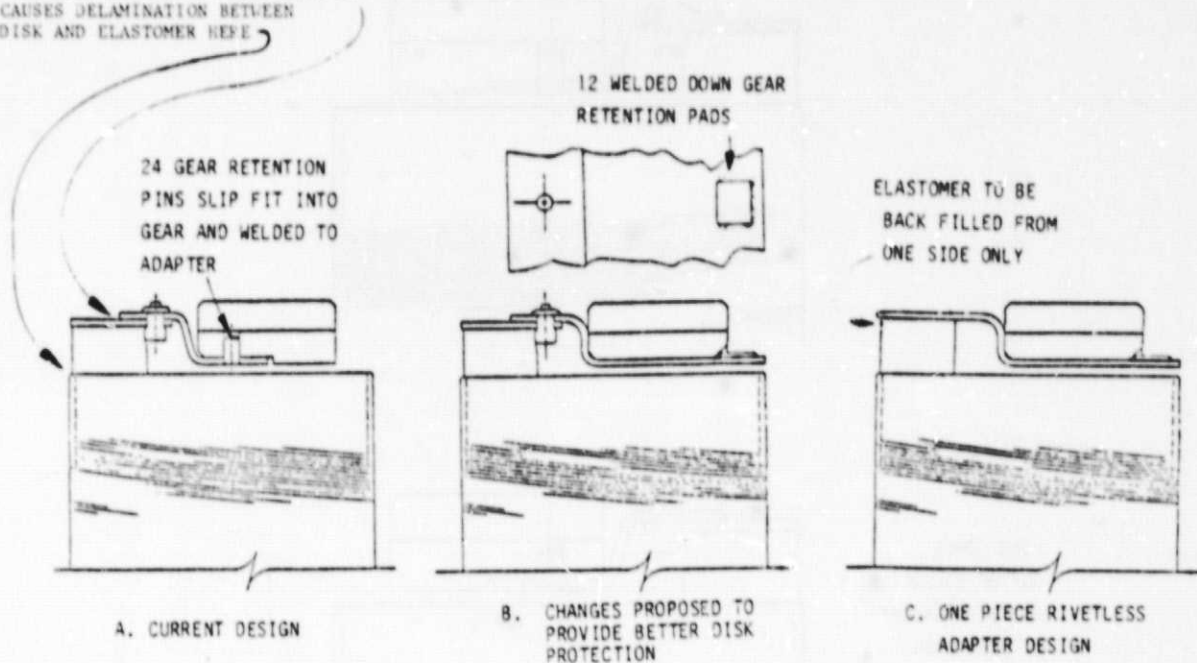
POOR FIT OF ADAPTER PIECES AND  
PULL DOWN ACTION OF RIVET HERE  
CAUSES DELAMINATION BETWEEN  
DISK AND ELASTOMER HERE

Figure 102. Evolution of ring gear mounting adapter to provide improved matrix protection and eliminate rivet problems.

The second rivet-related problem encountered was a result of poor fit at the rivet joint between the two metal pieces of the gear adapter as shown in Figure 102. On some disks, there is a gap between the adapter pieces that is pulled closed by the rivet thus putting tension on the disk-elastomer joint.

Damage caused by rivet heads as well as circumferential disk cracks caused by a poor fit between the gear adapter pieces led to a design that eliminates the rivet joint. This is shown in Figure 102. Having gained experience in

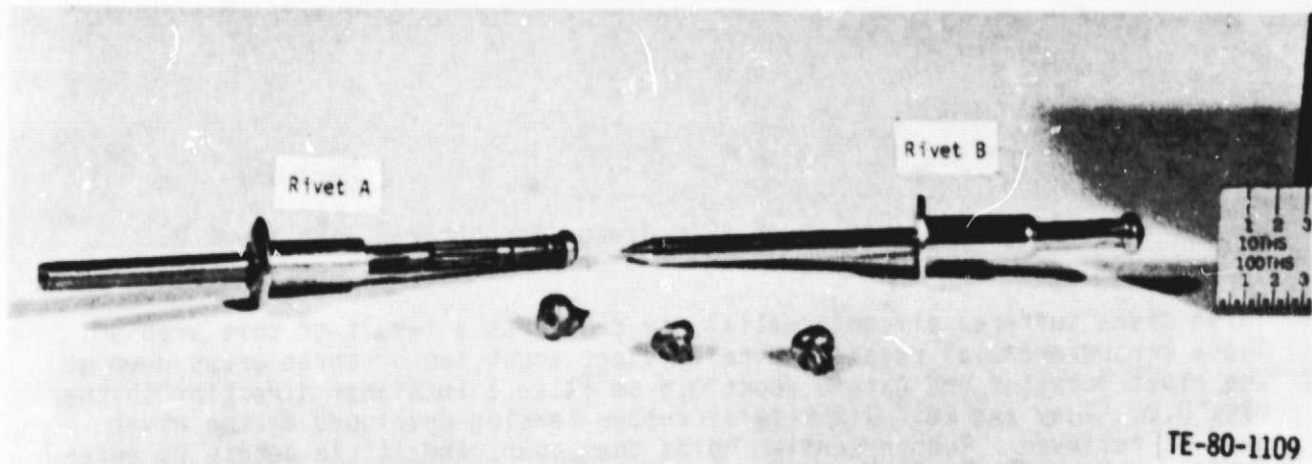
A rivet failure problem, which occurred when one rivet was substituted for another in the attachment of the gear, caused a disk to be damaged beyond further use. The mechanism of failure is shown in Figure 103. As shown in Figure 104 when rivet A is installed the head of the rivet "pull" shank is well trapped in the rivet collar. This head of rivet B is not well trapped, and it works loose when the disk assembly is used. When the disk is at room temperature, dimension X is too small to let the rivet head work into the space between the gear and matrix rim, but when the gear expands with temperature and is distorted further by action with the drive pinion, the rivet head can work its way into this space and dig into the core rim as shown in Figure 104. This caused failure of disk E77250A (GM15-14) as shown in Figure 105. The ring gear has been removed from the disk in order to show the damage to the core.

Figure 103. Unused rivets A and B and rivet heads that came loose from used type B rivets.

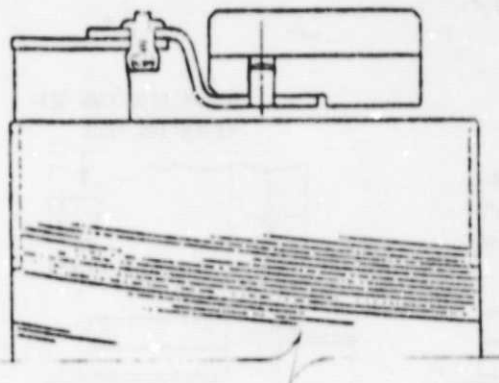
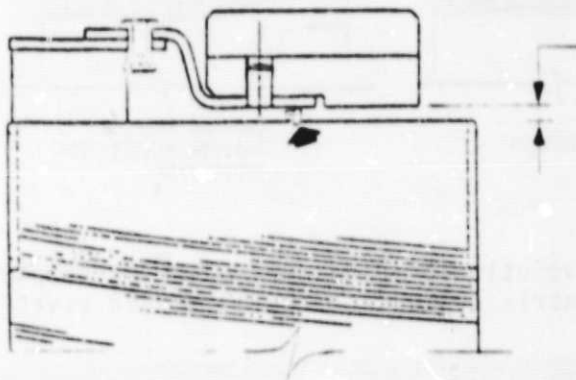
RIVET A -  
HEAD REMAINS  
WELL TRAPPED

RIVET B

HEAD COMES  
OUT OF COLLOR  
AND GETS CAUGHT  
BETWEEN DISK  
AND GEAR

Figure 104. Mechanism of disk damage encountered with rivet B.

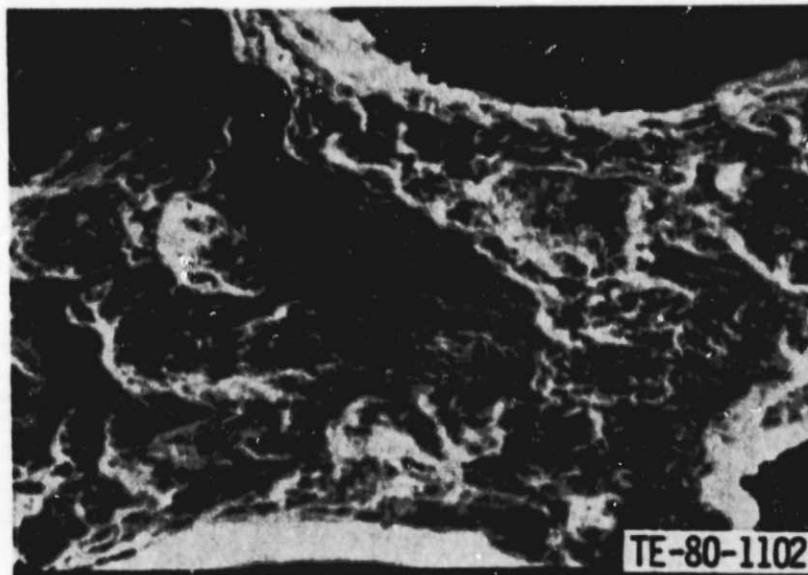
The seal/matrix contact areas, in all areas where photomicrographs were made, were small fractions of the total projected area of the matrix. Figure 108 typifies the contact areas seen (the sliding seal material scuff marks can be discerned in the flattened area of contact). When this flattened area is examined at 1500X, the surface shown in Figure 109 is seen. The mosaic crack pattern is strongly suggestive of a remelted surface. Table XXV at the 15.2 cm (6.0 in.) radius gives the microprobe estimate of the cation chemistry. (Oxygen was the anion in all cases.)

Two things emerge from this data. First, significant transfer of nickel from seal to AS matrix is taking place, both at 460 and 3050 h. Second, both the mosaic crack pattern and approximate calculations indicate that temperatures well above ambient are generated by frictional heat at the areas of contact. The highly localized nature of this thermal effect is caused by the low thermal diffusivity of the AS matrix,  $0.012 \text{ cm}^2/\text{s}$  ( $0.04 \text{ ft}^2/\text{hr}$ ). The role of the calcium fluoride is not clear at this point.

Figure 108. Disk 14A-07, 3050 h, radius 15.2 cm (6.0 in.) seal/matrix interface. (300X)
